INSPECTION REPORT: KENSINGTON GOLD MINE

Date of Inspection: Monday September 23, 2019
Date of Report: Monday October, 7 2019
USDA Forest Service Inspector: Richard Dudek

This inspection included the Access roads, Comet Development Pile, Comet Water Treatment Plant (CTWP), Sherman Creek Outfall 001, Pit 4, mud dump, the TTF area, and the fuel depot.

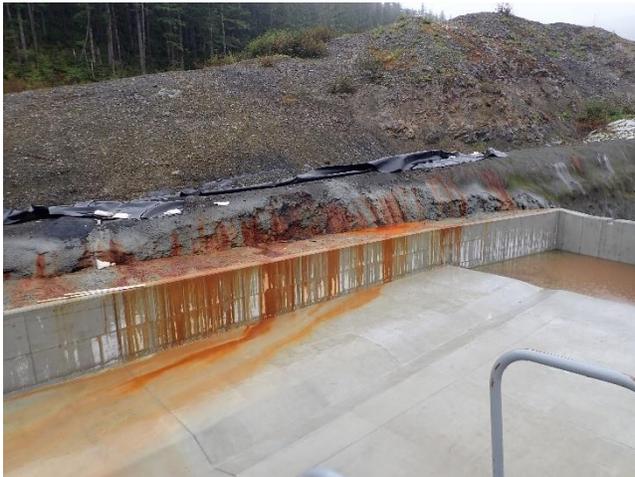
- **Mitigations and modifications are required at the TTF dam spillway to prevent acid rock drainage (ARD) from entering the spillway and outfall 002 (Photo 1).**
- **Stormwater BMPs (silt fencing) on Comet Road bridges need maintenance or replacement**

On 9/23/2019, it was observed that ARD had pooled up on the gravel patch along the side wall, and then flowed onto the floor of the spillway. Coeur Alaska will be providing ADEC with a brief summary for the corrective actions taken to prevent future ARD releases at this location.

Photo 1. ARD seeps in the dam spillway.

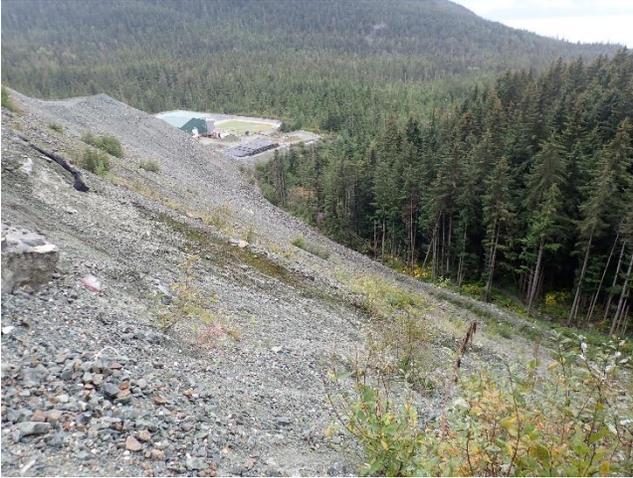
Coeur Alaska continues to deposit waste rock from the Raven drift at this location (Photo 2).

Photo 1. The Comet development pile.

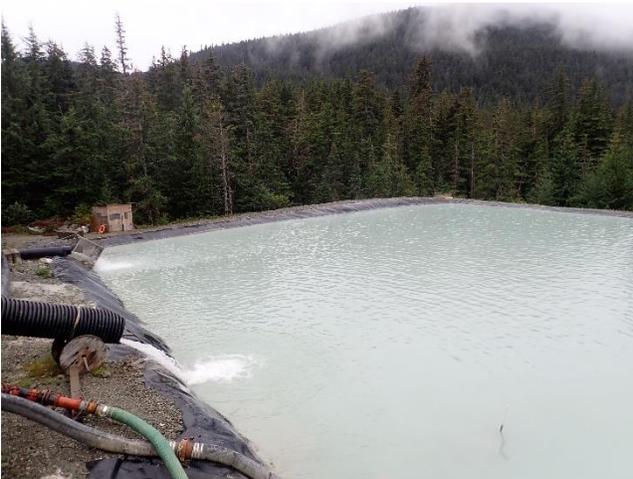
On 9/23/2019, the CWTP was treating 1,095 per minute (gpm). Pond-1 (Photo 3) was receiving mine site water. Pond-2 (Photo 4) was receiving backwash from the water treatment plant.

Photo 2. Pond 1.

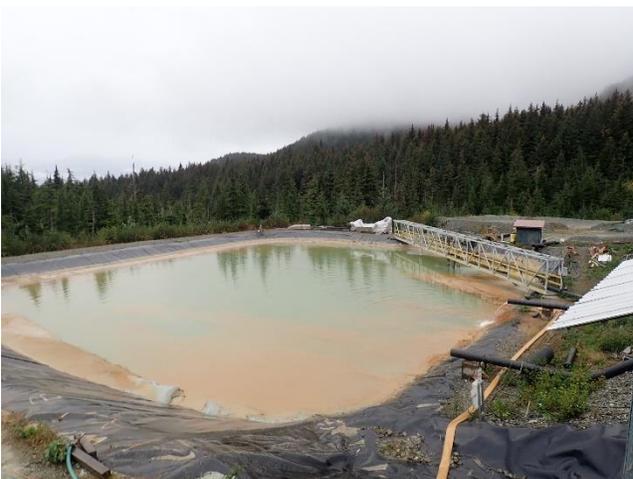
Photo 3. Pond 2.

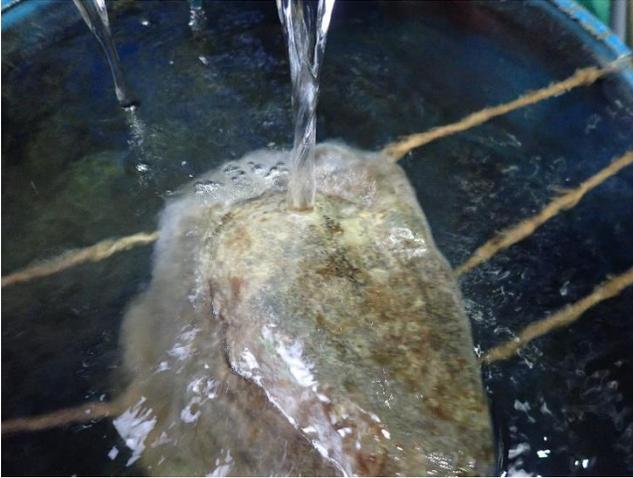
White material was observed on the test rock used for monitoring white material (Photo 5).

Photo 4. The test rock for white material accumulation.

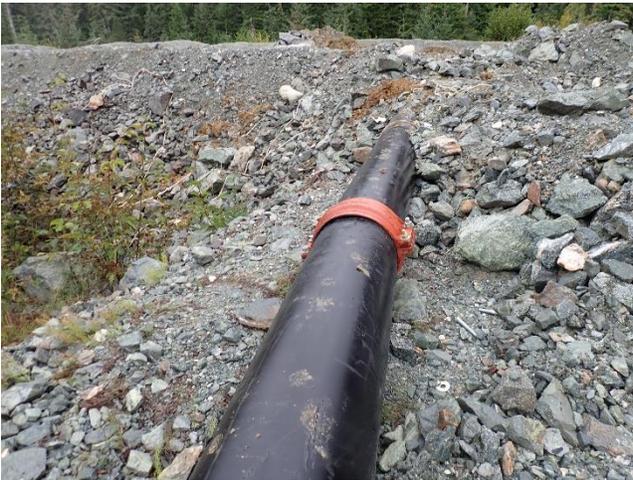
The water return pipeline (Photo 6) for the de-watering bags has been fixed.

Photo 5. The dewatering bags sump water return pipeline for Pond 2.

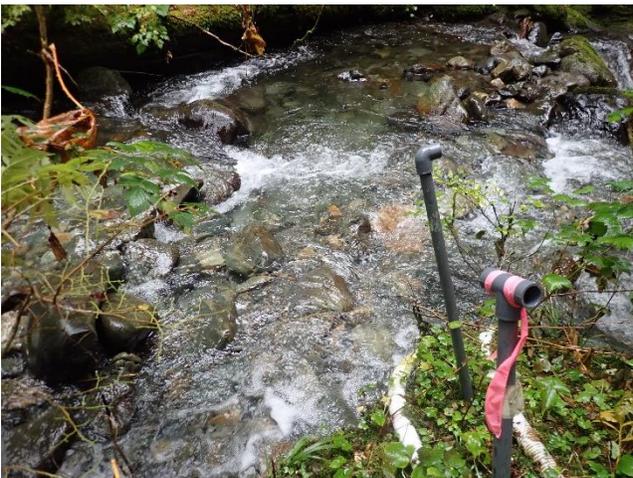
White material was observed in the creek bed (Photos 7).

Photo 6. Sherman Creek outfall 001.

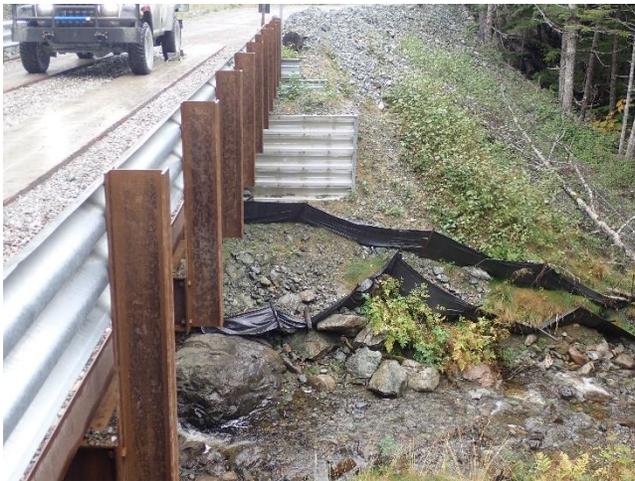
The No Name Creek Bridge requires new silt fencing at the north abutment (Photos 8-9). The Sherman Creek Bridge needs new silt fencing installed along the south abutment (Photos 10-11).

Photo 8. Silt fencing along the north abutment needs to be replaced.

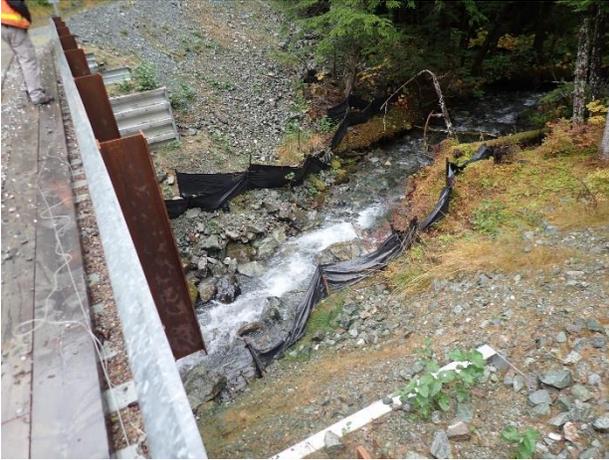
Photo 10. Silt long the south abutment of Sherman Creek Bridge needs to be replaced.

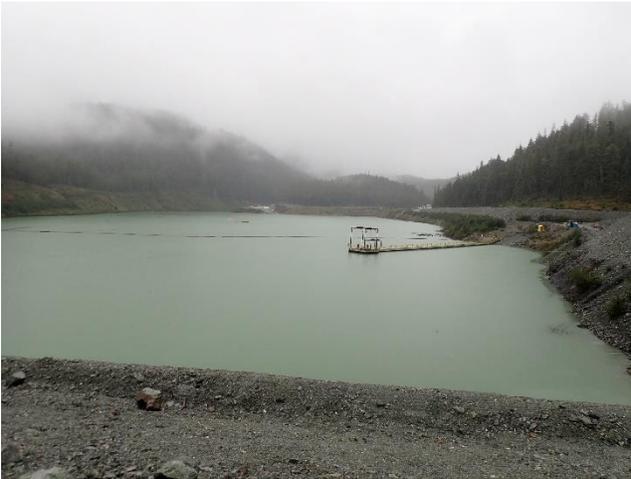
The TTF's recorded water level on 9/23/2019 was 704.35 feet (Photo 12), and algae was observed in the TTF. After discussing the algal bloom with TTF water treatment plant supervisor. He stated that so far no issues have occurred with algae clogging the water treatment filters.

Photo 11. The TTF.

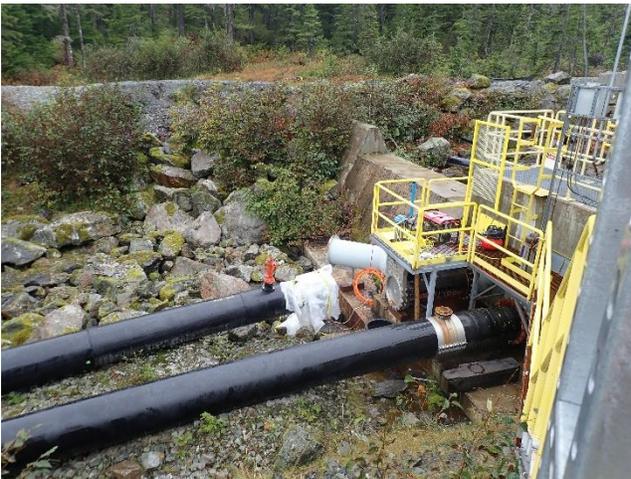
In the previous inspection report, IR 175, dated 8/21/2019. It was incorrectly stated that the second diversion pipeline project was completed. As of 9/23/2019, the installation of the second diversion pipeline for the Upper Slate Lake is almost complete (Photo 13). The final project tasks will include connecting the pipeline into the bypass (Photo), and conduct a pressure test to ensure no leaks are present.

Photo 12. The bypass for upper Slate Lake.

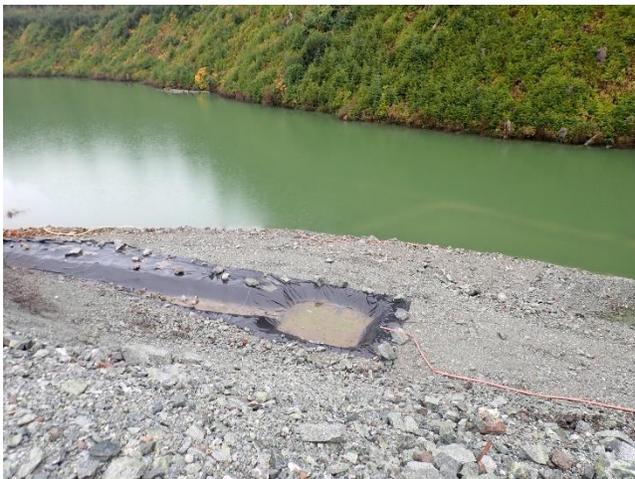
There were no ARD plumes observed in the northern TTF area (Photo 16).

Photo 15. The northern TTF area ARD collection sumps.

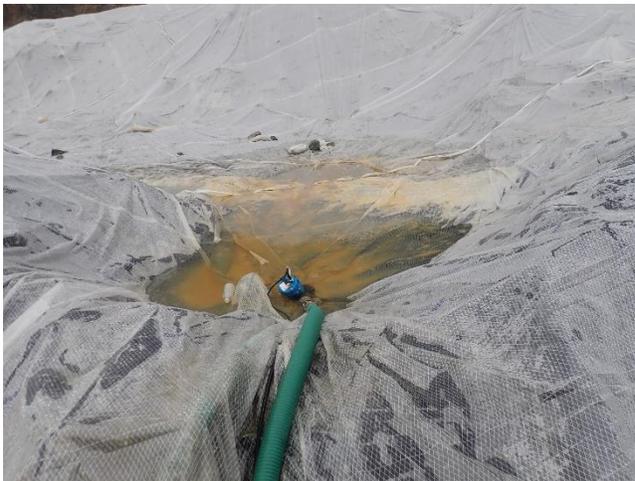
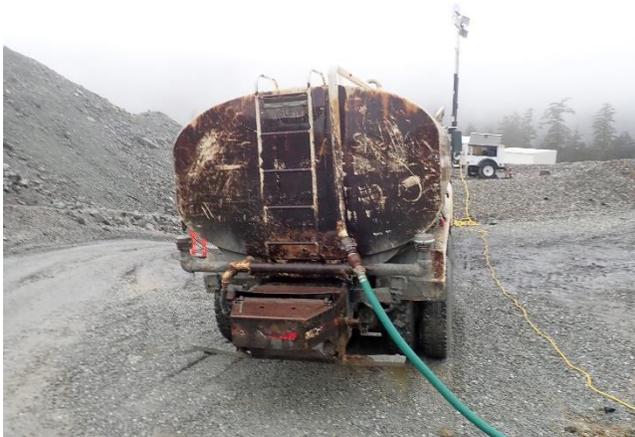
Coeur personnel continue to dispose of the graphitic phyllite (GP) as cemented underground backfill (Photo 17). Some ARD generation was observed on the liner for the GP stockpile. Coeur personnel were able to contain ARD and remove it immediately (Photos 18-19).

Photo 17. The pump used for removing ARD.

Photo 18. The water truck used for collecting ARD.

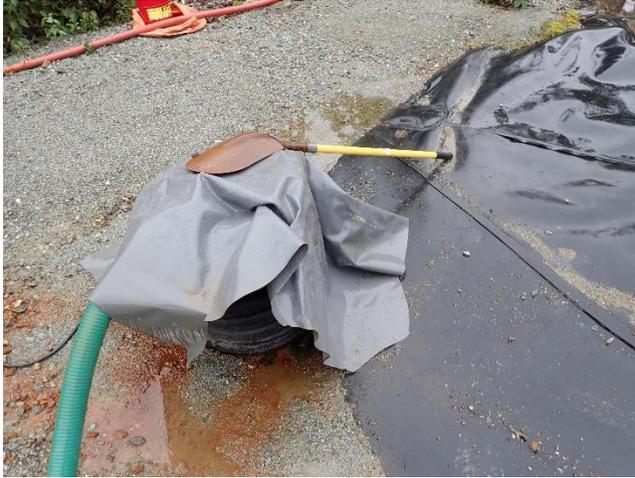
Storm water has accumulated underneath the HDPE liner for the GP stockpile. Environmental Operations is aware that water needs to be pumped out (Photo 20).

Photo 19. ARD collection drain for the mud dump GP stockpile.

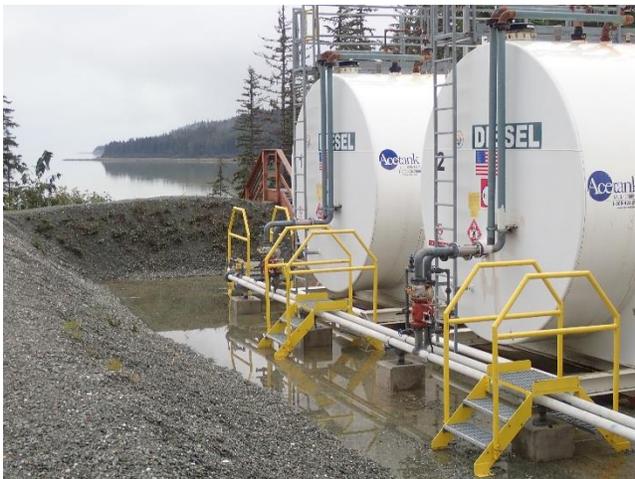
No fuel sheen and/or spills were observed in the fuel tanks gravel pad and at the refueling pad (Photos 23-24). Due to recent storm events, some water had pooled up in the southeast corner of the fuel tanks gravel pad (Photo 25). The fuel supply contractor also manages the water removal from the fuel tanks gravel pad.

Photo 24. No fuel sheening observed.

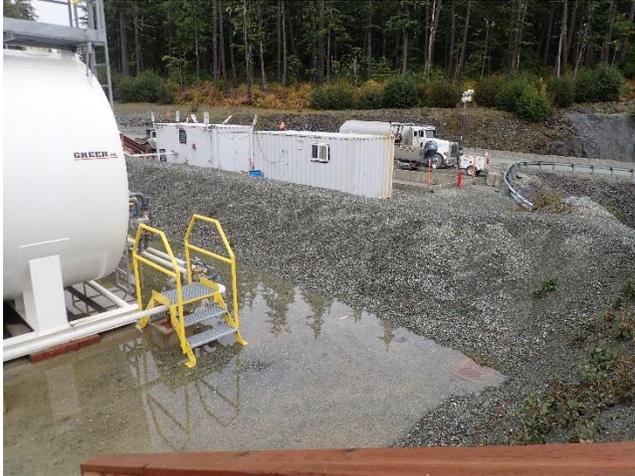
Photo 25. The fuel depot.
